Massachusetts Department of Environmental Protection
Bureau of Resource Protection – Watershed Permitting Program
Sanitary Sewer Overflow (SSO)/Bypass
Notification Form

Hull, MA WPCF

Unauthorized Discharge Summary Hull WPCF [08-08-18]

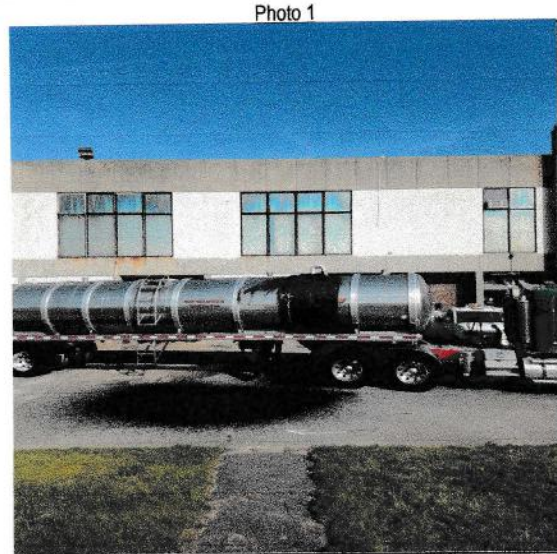
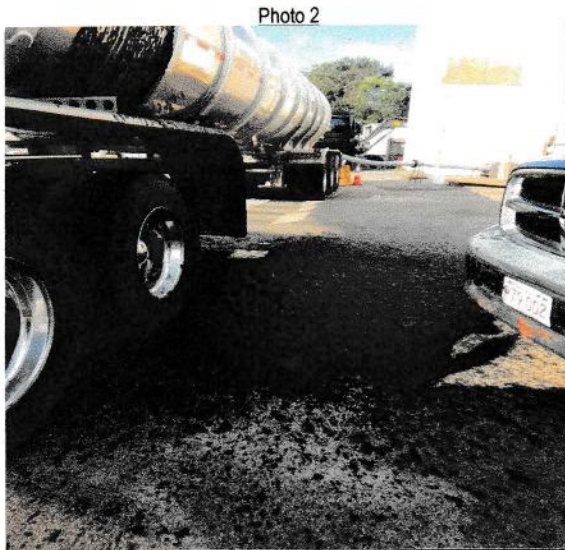
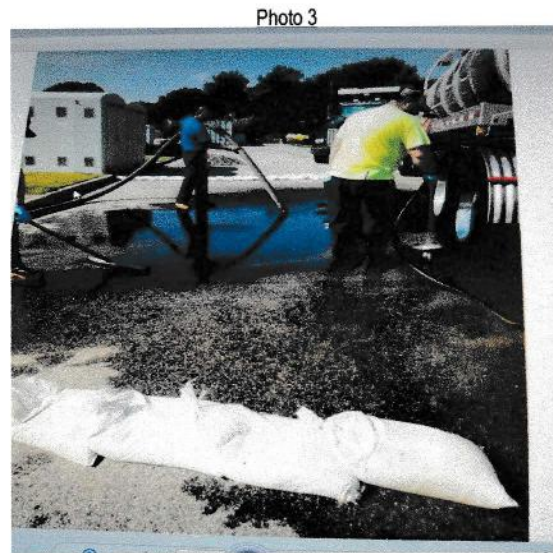
6. Cause of SSO Event: Other - Specify Below
Rain Event, PS Failure, Insufficient Capacity in System, Treatment Unit failure, Sewer System Blockage, Pipe Collapse, Root Intrusion, Grease Blockage, Other
Specify: Other: Operator error. Truck driver was monitoring filling of truck using the truck's sight glass, which did not indicate adequately how full the tanker truck was. The notification to shut off feed pump was made a little too late, causing slight overfill.

ARROW SHOWS AREA WHERE TRUCK PARKED

Corrective actions taken to prevent reoccurrence of unauthorized discharges at the same location;	<i>Review sludge truck filling procedures with plant staff and trucking company. The truck's sight glass does not give early enough warning and a visual inspection of the tank is necessary.</i>
Date of the last unauthorized discharge in the same general location;	<i>The last incident at the treatment facility was on 3/3/18 [winter storm].</i>

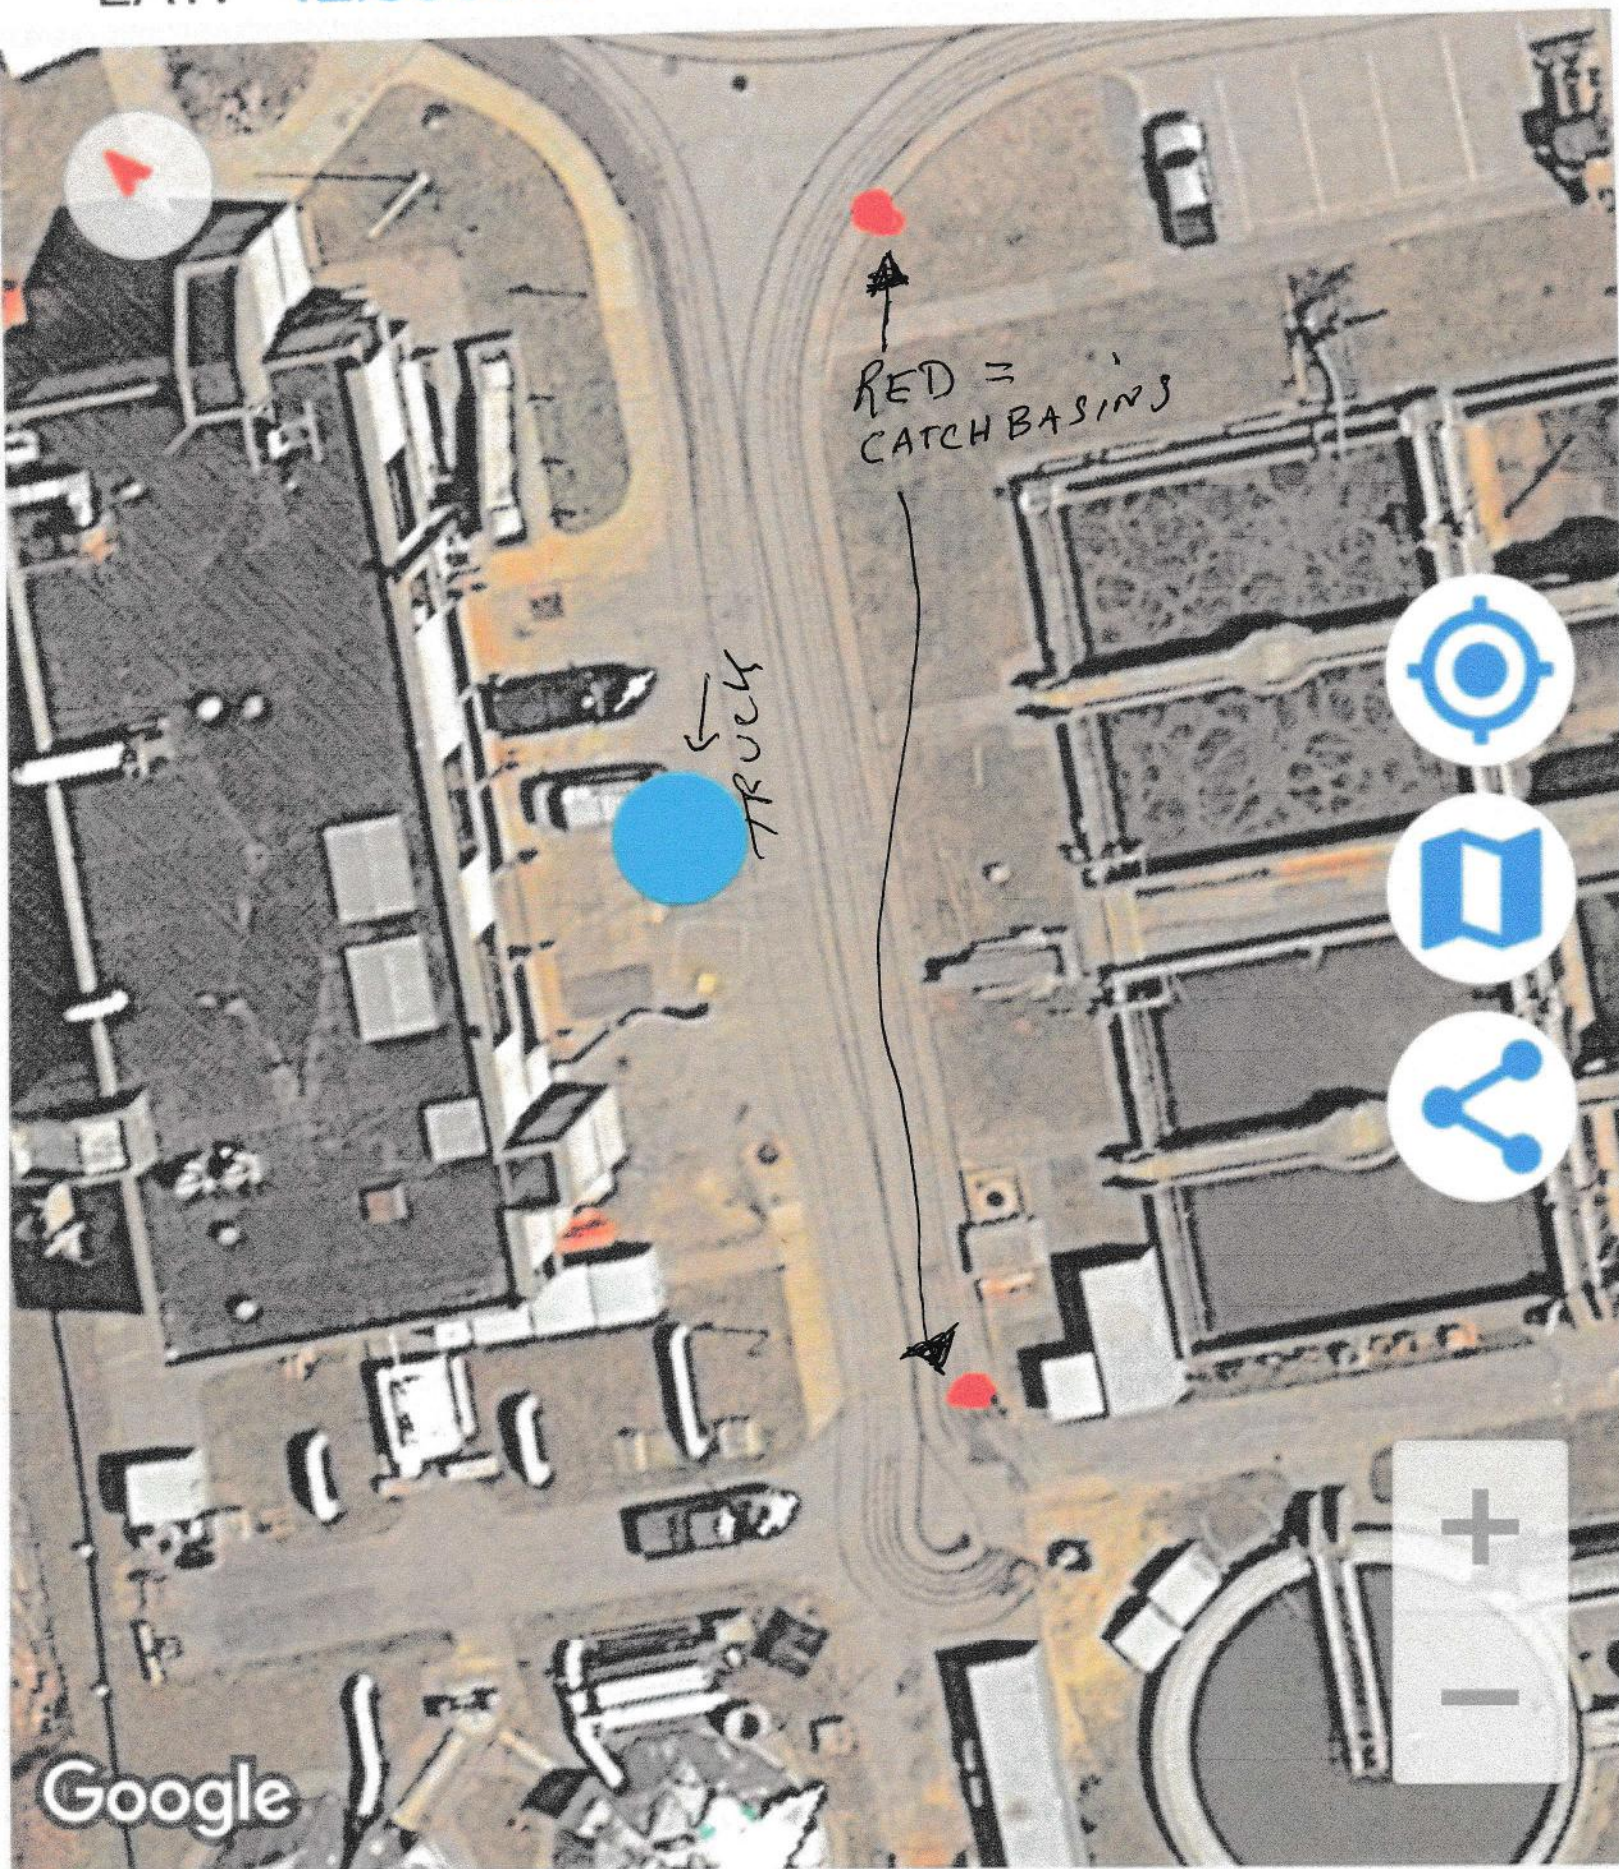
If the release occurred to the ground, provide the location of the nearest down-gradient catch basin and the name of the receiving water to which the catch basin discharges;	<i>Nearest down-gradient catch basin is just past the truck location on both ends of truck in the plant driveway. Catch basins drain toward Hull Bay.</i>
Did the release reach a wetland or surface water? If so, include the name and exact location where?	<i>No</i>
Measures taken to minimize the volume and duration of the unauthorized discharge;	<i>Sand bags set up as well as catch basin "spill mats" in the event any liquid were to reach the catch basins. No material reached the catch basins.</i>
Measures taken to clean the area where the unauthorized discharge occurred;	<i>All solids were vacuumed up, then the asphalt area was hosed down and this water was vacuumed up. Sodium hypochlorite solution sprayed on affected areas, and this areas was then washed down, with all wash water vacuumed up.</i>

- picture 1 - area of sludge on Bay side of truck - very localized
at truck.
- 2 - cleaning/vacuuming up of sludge
- 3 - washed down area (driveway)
- 4 - sludge truck tanker vent
- 5 - area clean-up - contained within sand bags,
